# MALINE CREEK ASBESTOS SITE CLOSURE AND STREAMBANK STABILIZATION STUDY

ST. LOUIS, MISSOURI

March 1993

**TapanAm associates, Inc.**  
Engineers • Architects

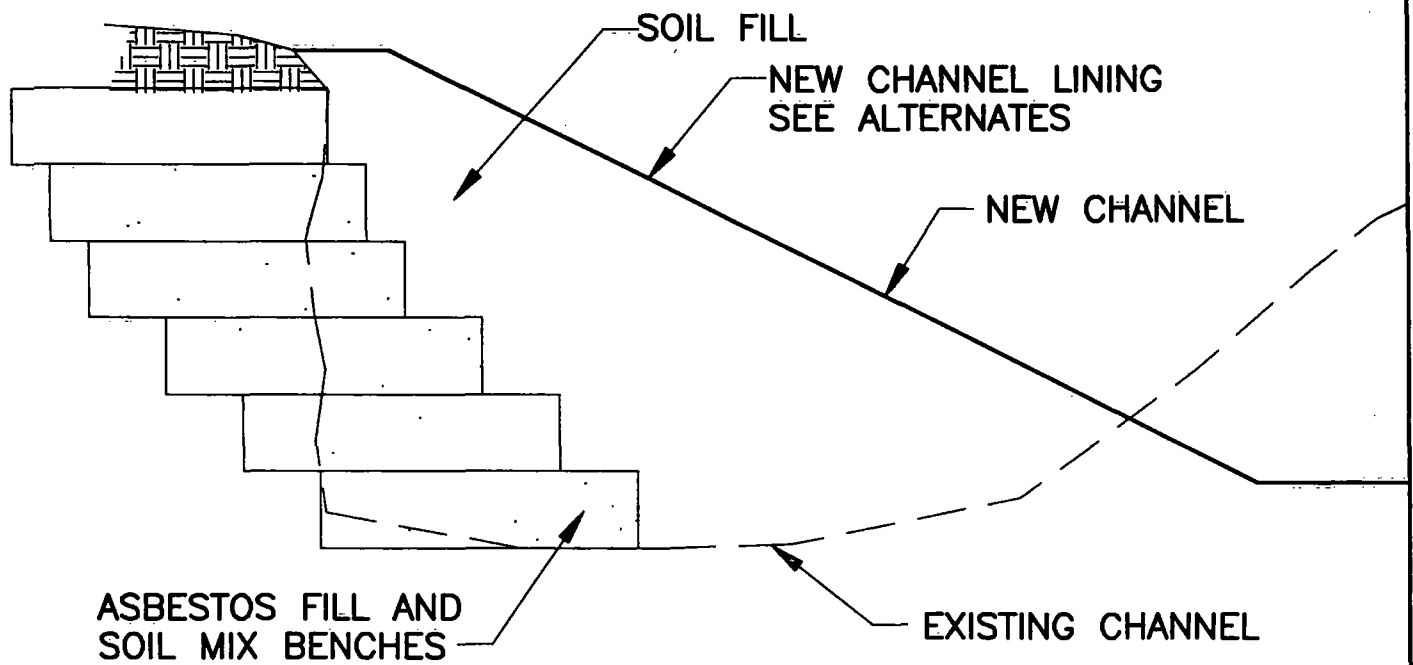
**FIGURE IV-1  
SUGGESTED ASBESTOS  
DISPOSAL & STABILIZATION  
TECHNIQUE**

All three of the alternatives have a common asbestos scrap collection and disposal method. Essentially, all asbestos material within the channel bed and along the southwest banks will be collected and placed in the northeast banks. The scrap will be sealed in benched lifts with soil to act as a binder. The lifts will be further sealed in soil prior to channel lining construction (Figure IV-1). This will involve shifting the channel bed to the southwest to provide working space for bench construction and to provide soil borrow to construct the benches and rebuild the embankment.

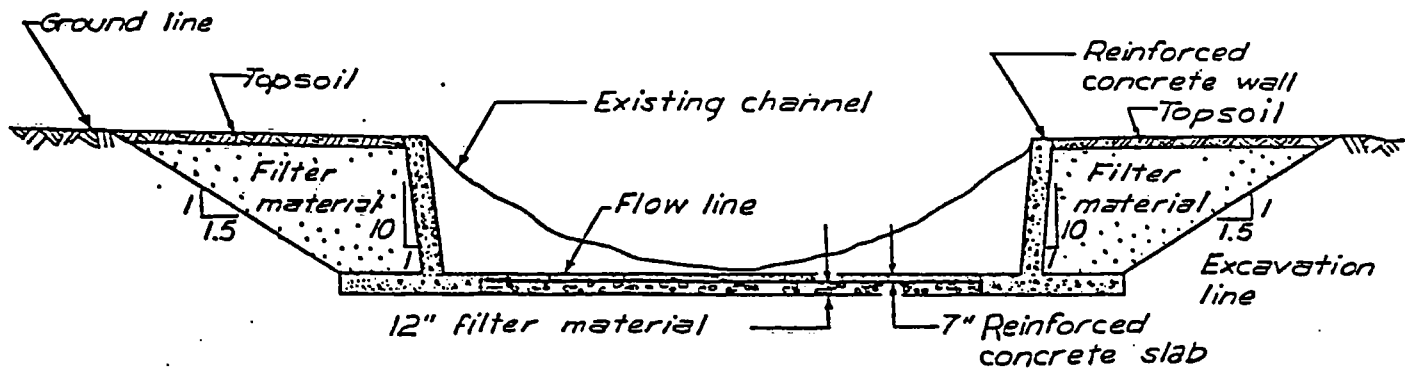
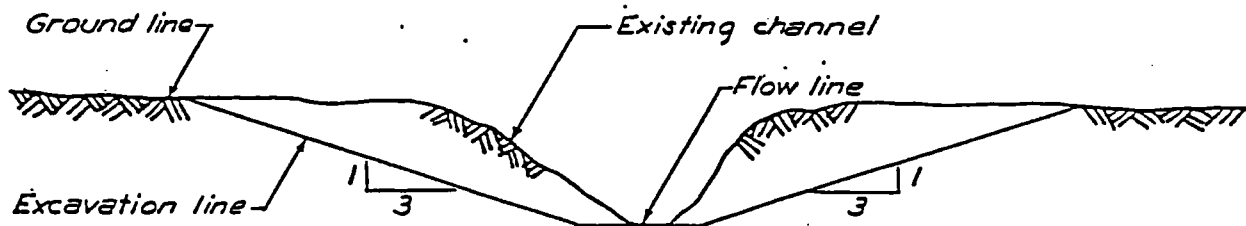
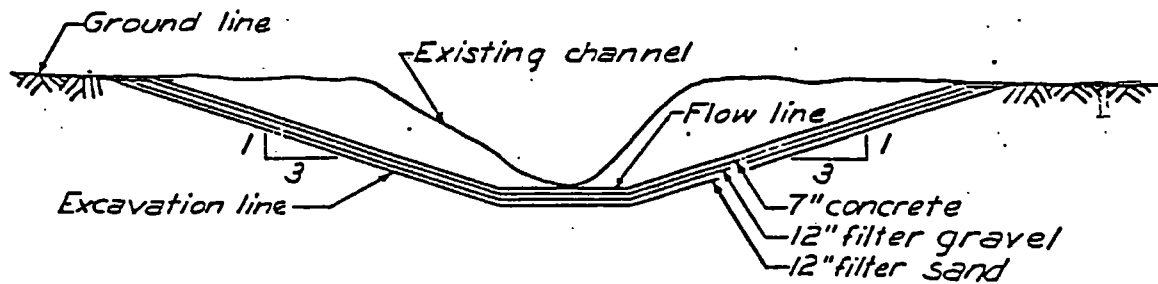
After examining a variety of channel section shapes and linings along the improved reaches of Maline Creek, including many which have failed, Simons, Li and Associates concluded that three typical sections were appropriate for use in modifying the creek depending on local hydraulic conditions (Figure IV-2). The Metropolitan Sewer district which has experimented with a number of section shapes and linings will accept most competently engineered solutions. However, the MSD will only assume maintenance responsibilities for vertical reinforced concrete retaining walls with reinforced concrete channel bed linings. Retaining wall structures are extremely expensive. One installed
